## Changes in BRCA MASTR v2.1 compared to BRCA MASTR v2.0

### Rationale

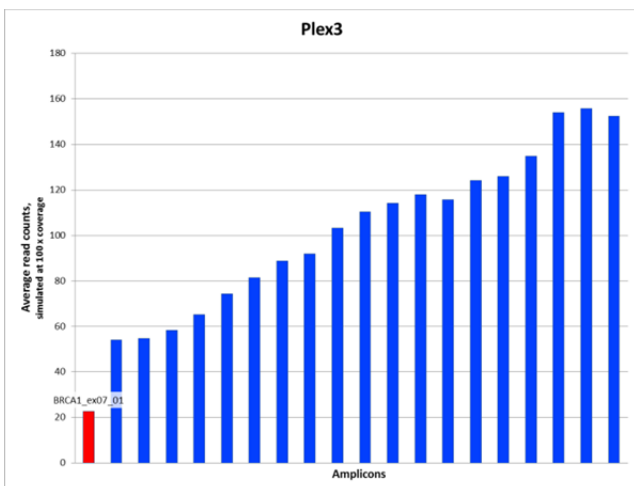
### BRCA MASTR v2.0

Amplicon BRCA1\_ex07\_01 had the tendency to show low read counts. Detailed analysis revealed this was caused by the combination of a polymorphic GAA-repeat and the presence of a 12bp long poly-A stretch. We opted to ban the polymorphic GAA-repeat from any amplicon and found a solution in which both amplicons for BRCA1 exon7 were replaced by 1 amplicon encompassing the entire exon. Please note that the total number of amplicons is now reduced to 93.

- Resulting read counts:
